**title:** REFLECTIVE FLOOR FINISHES FOR AIRCRAFT  
MAINTENANCE HANGARS

**author:** Robert L. Alumbaugh, Ph D, and David Gurganus

**date:** May 1977

**sponsor:** NAVAL FACILITIES ENGINEERING COMMAND

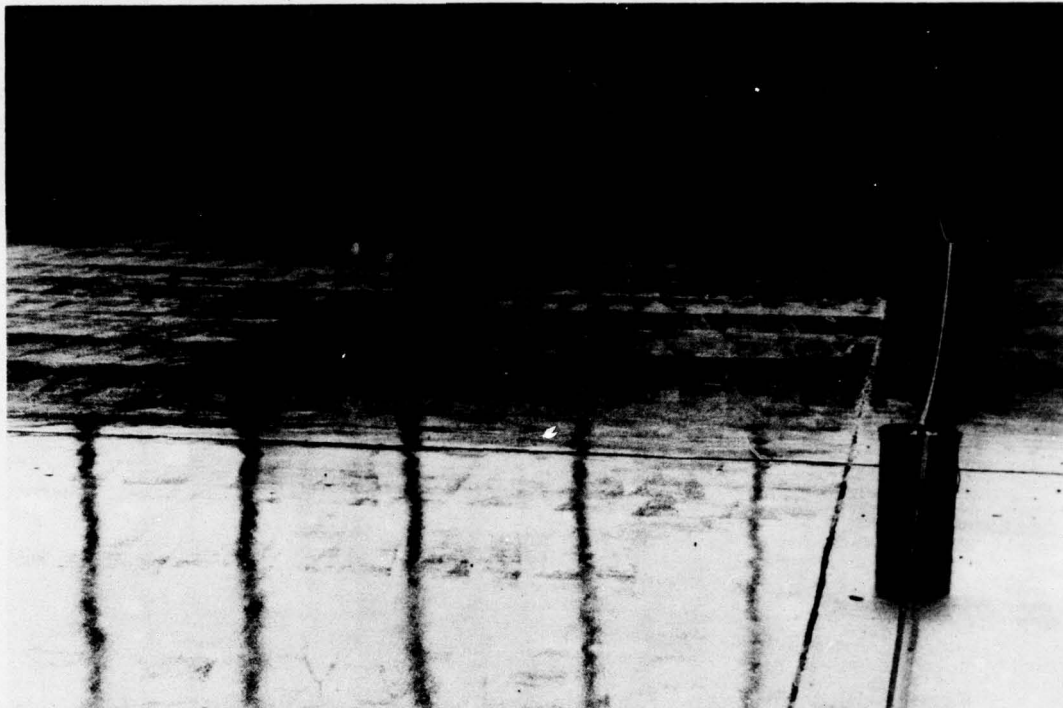
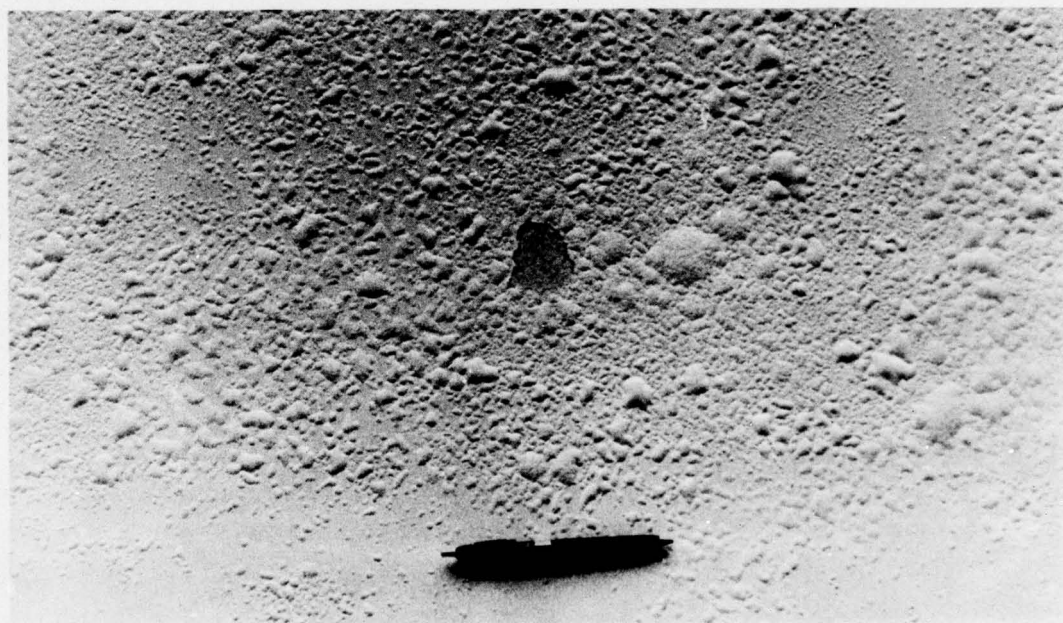
By late afternoon, the first finish coat had dried tack-free. At that time, there was no further blistering observed other than the normal pinpoint size. However, the following morning, much of the System C area exhibited severe blistering, from pinpoint up to about 2 inches in size. Figure 9(a) gives an overview of the system while Figure 9(b) shows a closer view giving an indication of blister sizes and frequency in one of the areas (note cleaned and spot-primed areas on hangar door in Figure 9(a)).

The day that the CRU primer and first finish coat of System C were applied was one of the hottest and most humid that occurred during the entire application. Temperatures were in the high eighties and nineties,

and the humidity was generally above 70%. These conditions were largely responsible for the blistering problems, and the manufacturer currently does not recommend application of this material above 80°F. The high humidity caused a certain amount of moisture to be retained by the concrete deck, even though it appeared dry. The combination of high temperature and humidity caused both the CRU primer and first finish coat to skin over and retain a larger amount of solvent than normal. It is believed that the blistering resulted from reaction of the urethane with moisture, producing carbon dioxide and vaporization of entrapped solvents. The vapor pressures of these gases were greater than the adhesion of the system to the deck. The volatiles could not escape because of the premature skinning on the surface of the coating systems and hence caused the blisters to form.

(a) Overview of CRU finish showing blistering.

(b) Closeup of CRU finish showing size and frequency of blistering.

Figure 9. CRU primer and first finish coat blistered badly due to high temperature and humidity.

The CRU primer was applied to the cleaned deck and allowed to cure sufficiently. This was followed by application of the two finish coats with a sufficient drying period between coats to prevent the blistering problem from recurring. Grit for nonskidding was again sprinkled into the first wet topcoat of one-half of this area (see Figure 6). No serious problems developed during the reapplication. However, because of the high temperature/humidity conditions, pinpoint blistering was still observed.

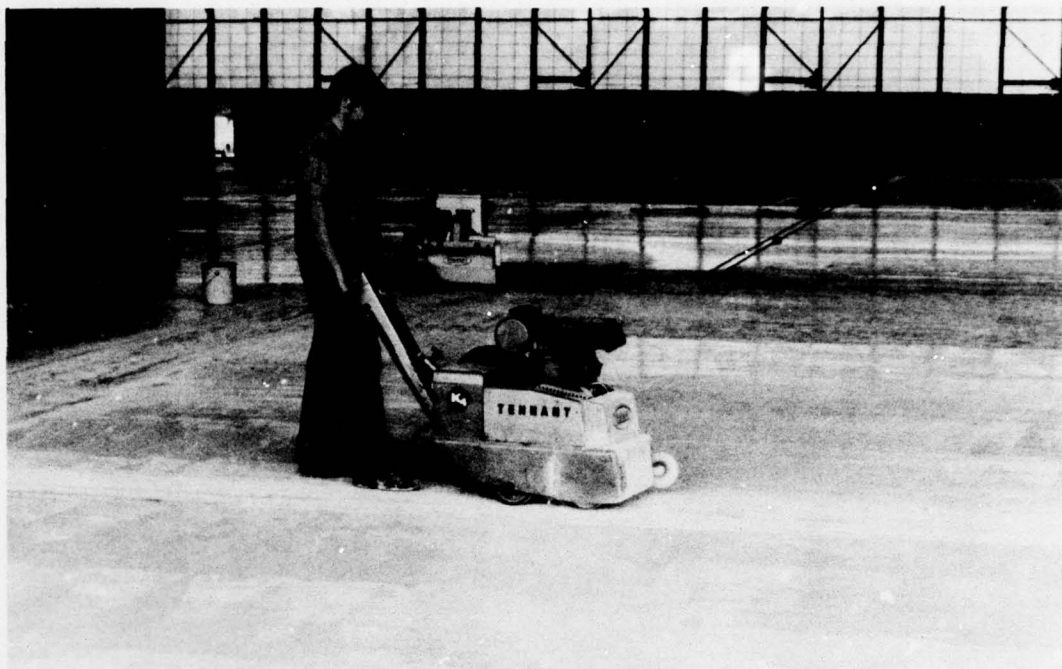
Figure 10. Removal of the CRU using a K-4 scarifying machine.

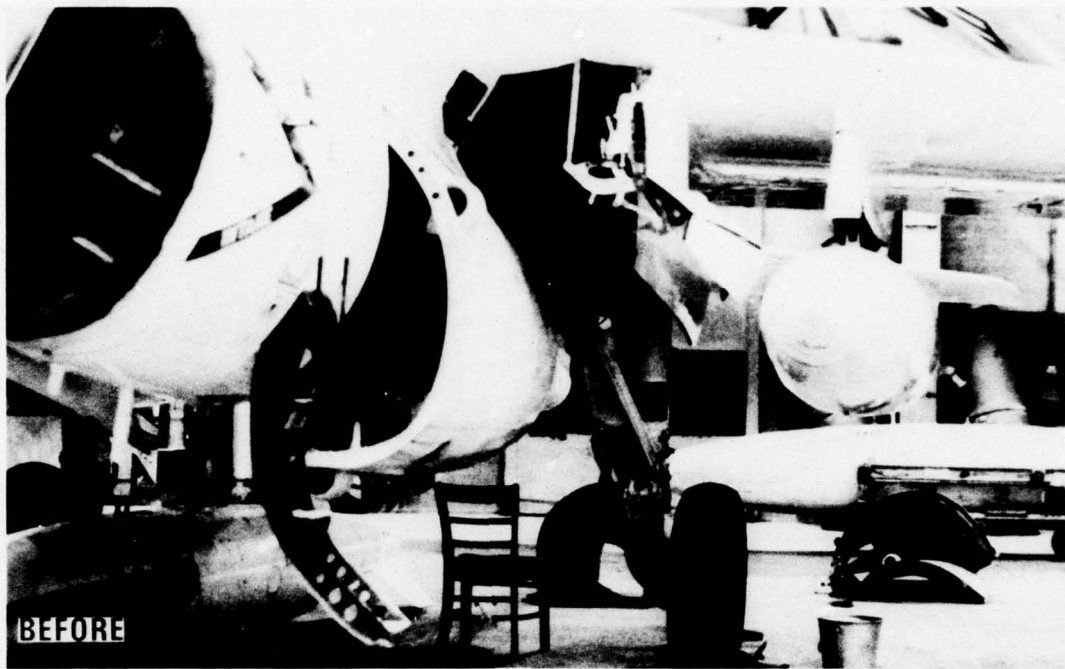
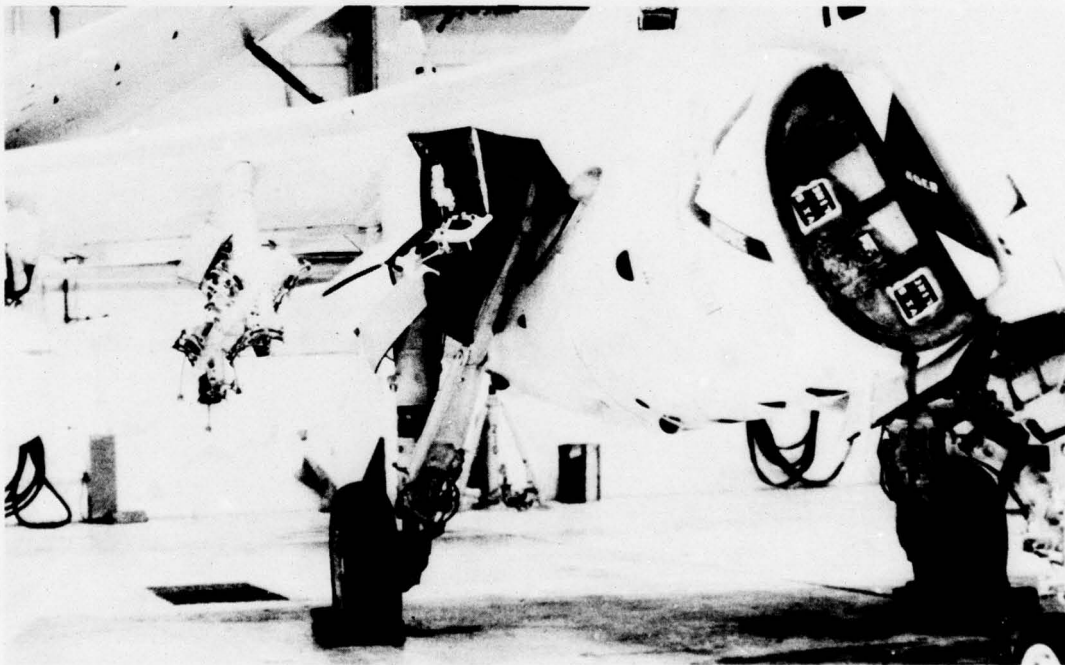
Figure 13. Comparison of underaircraft illumination on uncoated and coated hangar decks.

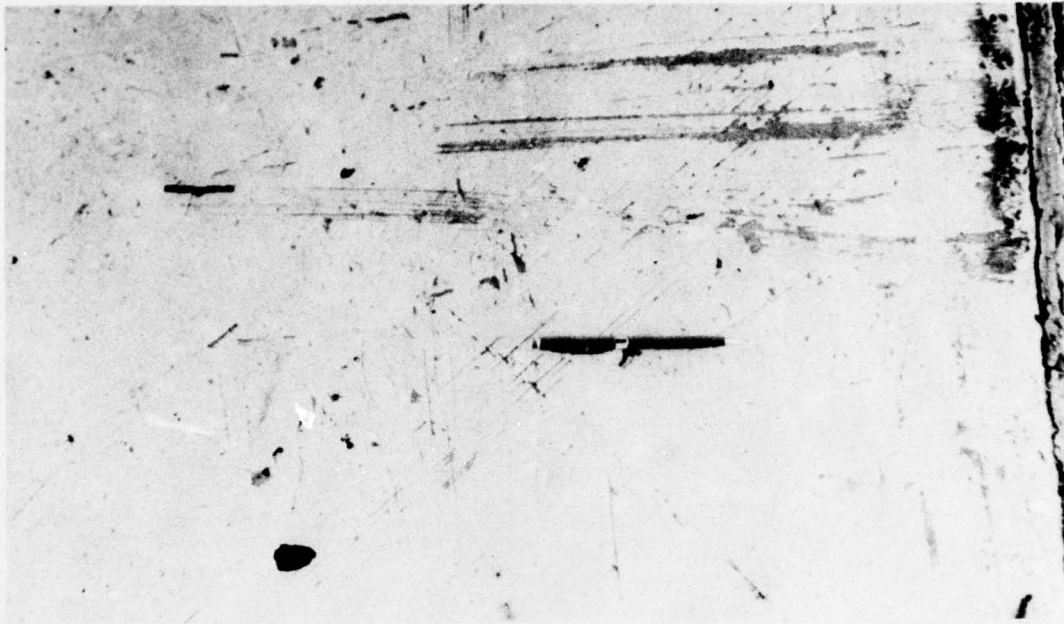
(a) Scratching and scraping by heavy equipment.

Figure 14. Damage to reflective floor finishes.

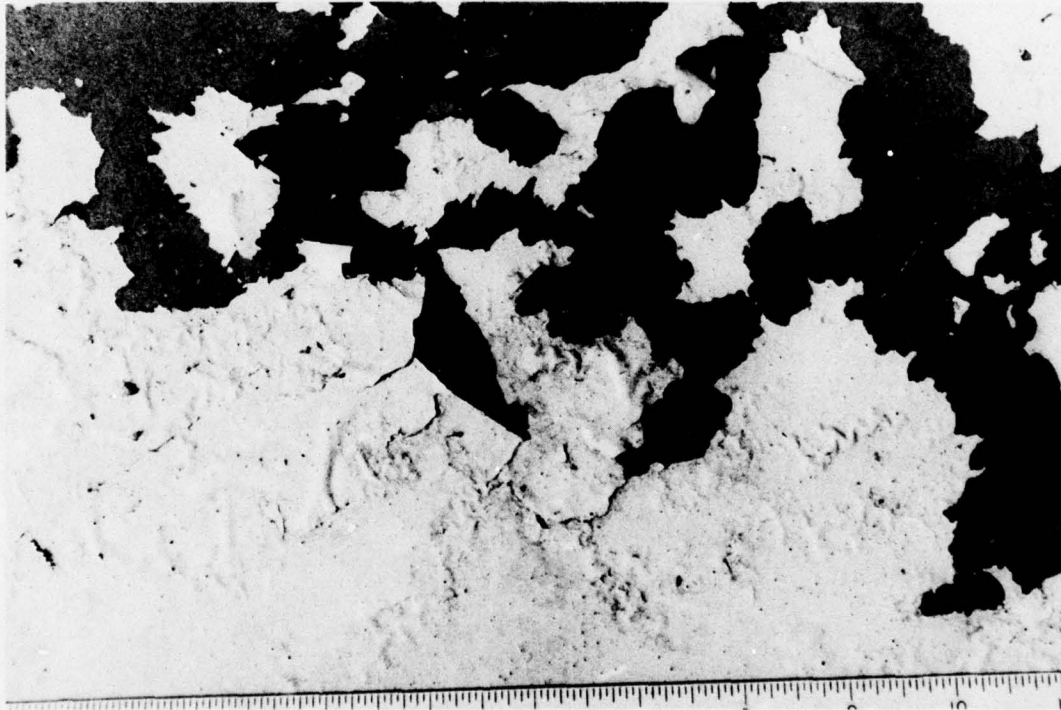
(b) Loss of bonding from chemical spills.

Because of the potential problem, the nongritted area of System A was recoated 12 months after the original application. This process consisted of chemically cleaning the surface to remove all contamination, mechanically abrading (sanding) the existing finish coat to provide a better bonding surface, and applying two coats of the same moisture-curing urethane as that used in System B. Although grit was broadcast into the first wet topcoat during this repair, it was applied very unevenly. As a result, there are still some small patches that do not have nonskid grit. Because of this repair, this area of System A is currently in somewhat better condition than much of the System B area. While there have been some problems in this new coating bonding to the old in the System A area (see Figure 15), this is considered very minor at this time. In addition to the above, one other very noticeable difference in the systems is the yellowing and staining of the moisture-curing materials (Systems A and B). The chemically resistant urethane (CRU) retained its whiteness very well which is due not only to its nonyellowing characteristics when exposed to sunlight, but also to its excellent chemical resistance which inhibits staining. Also, because of this chemical resistance, the CRU has been virtually unaffected by chemical spills, and no loss of bonding has resulted.

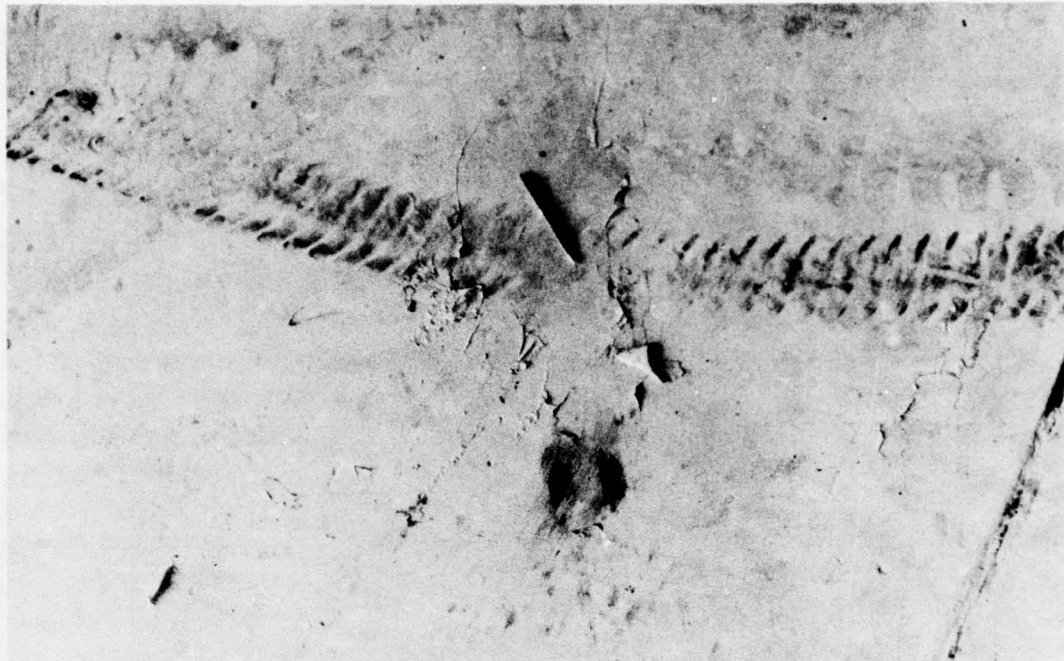
Figure 15. In a few small spots, new coating in System A area delaminated from original system.

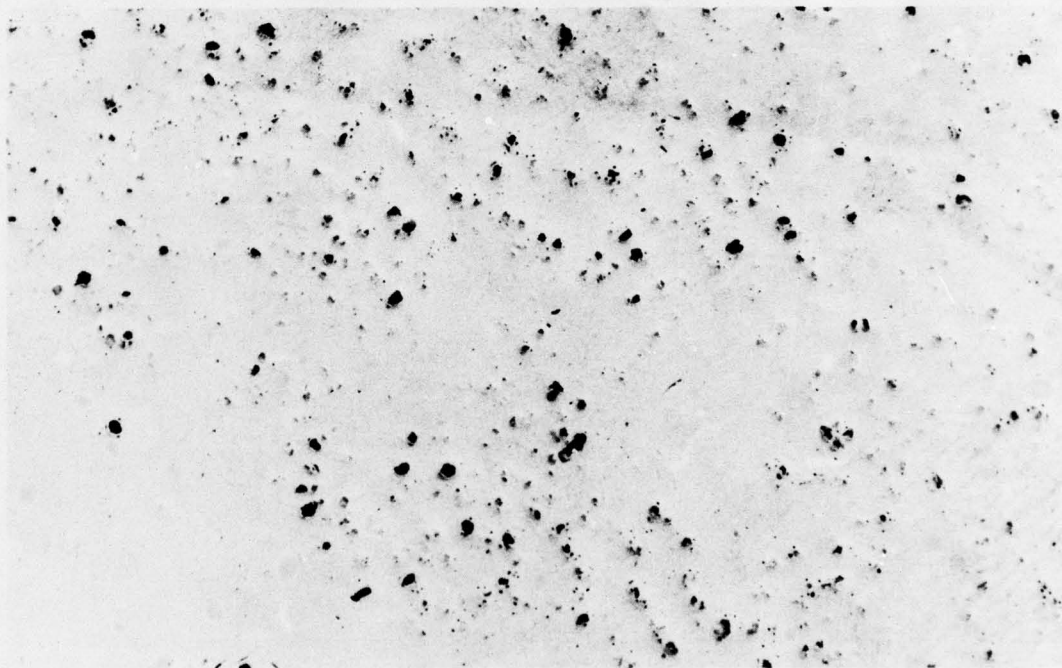
In spite of the performance of these reflective systems, all of them exhibit one common problem. That is, loss of nonskid grit that is crushed and removed from the floor system when heavy equipment is dragged or rolled across the deck. This loss of grit seemed to occur at approximately the same rate in all three systems. A typical condition is shown by a photomicrograph (Figure 16) of a reflective finish 2 years old, where the larger dark spots are in effect holes in the coating where the grit has been removed. This certainly reduces the nonskid character of the deck.

Figure 16. Photomicrograph of urethane reflective coatings after two years. Black holes in coating are where grit has been removed.
